Re: 121 Golden Isles Dr.

Hallandale Beach, FL 33009 Re: PL-BSIP-24-01703

ELECTRICAL SAFETY INSPECTION REPORT FORM

ELECTRICAL, MECHANICAL AND LIFE SAFETY REPORT:

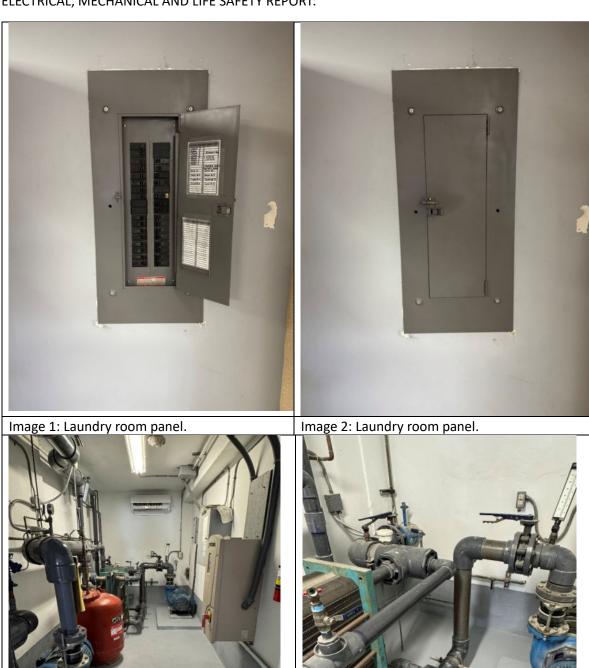
Image 3: Pump room.

Image 4: Pump room.
