Re: 121 Golden Condo Association
121 Golden Isles Dr.
Hallandale Beach, Fl. 33009
Re: PL-BSIP-24-01703

STRUCTURAL SAFETY INSPECTION REPORT FORM

STRUCTURAL REPORT:

Reinspection report April 28, 2025

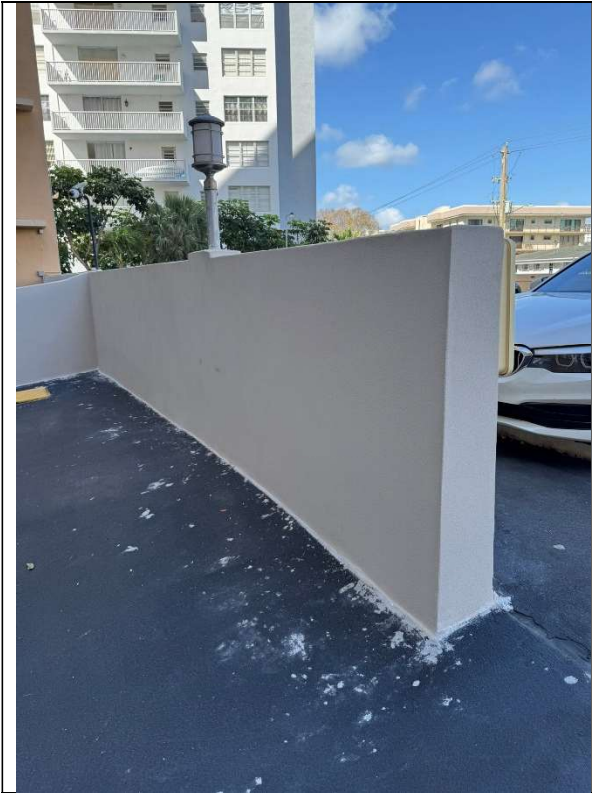
Image 2: Parking Building repairs completed.

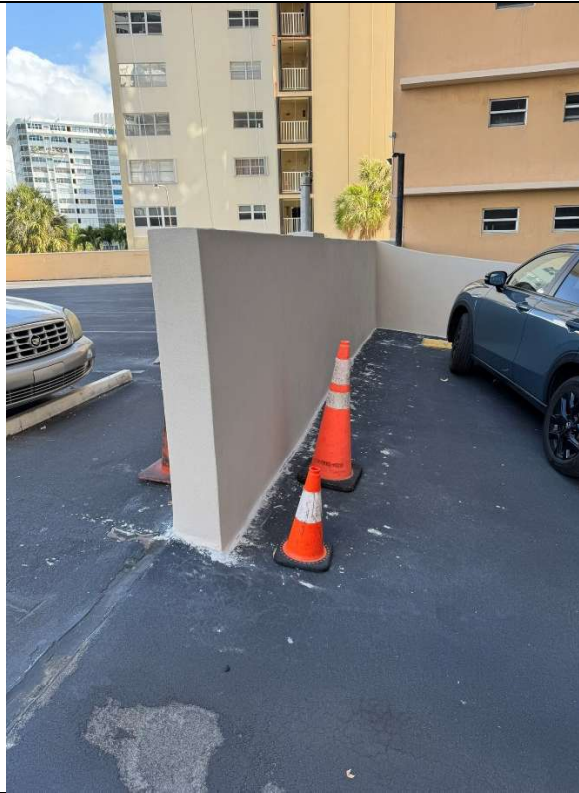
Image 3: Parking Building repairs completed.

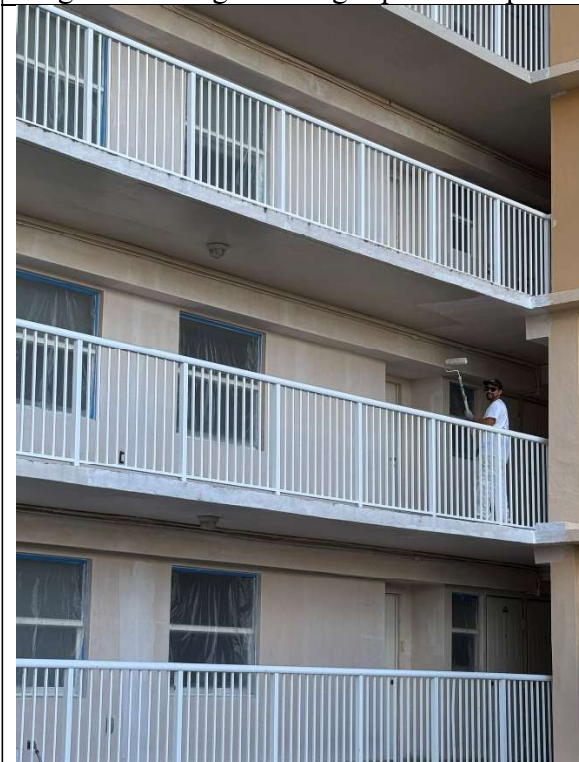
Image 4: Building elevation. South side. Repainted.

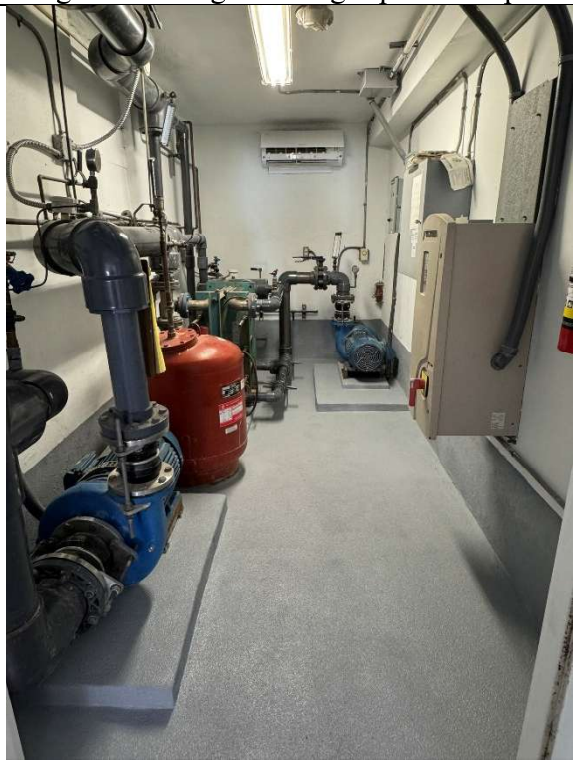
No cracks visible in foundation. In good condition.
Pump room area has been repaired.

Image 5: Pump room completely redone.

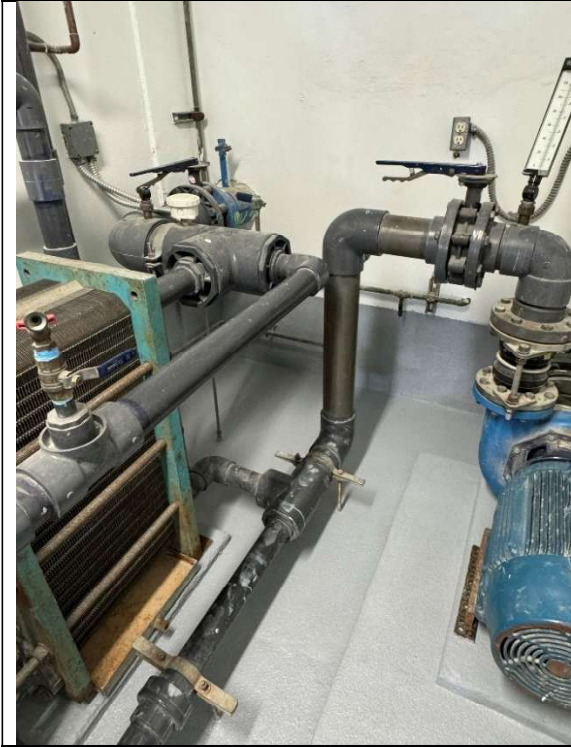
Image 6: Pump room completely redone.

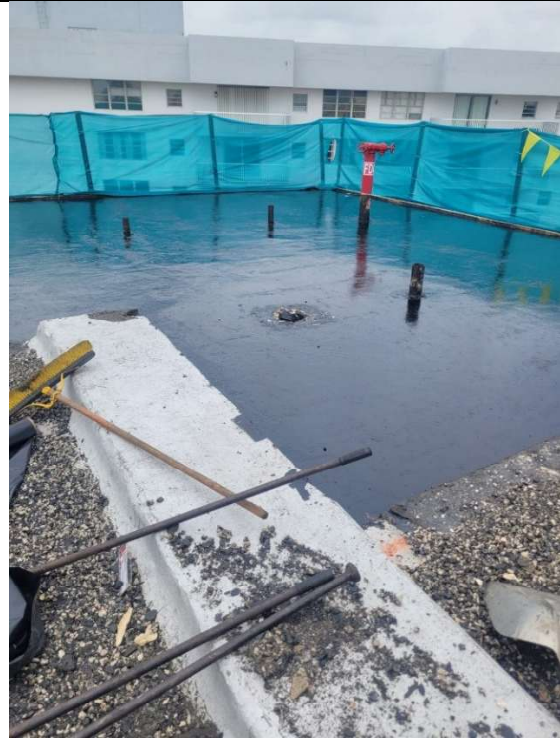
Image 7: Roof completely redone. Removal of old roof

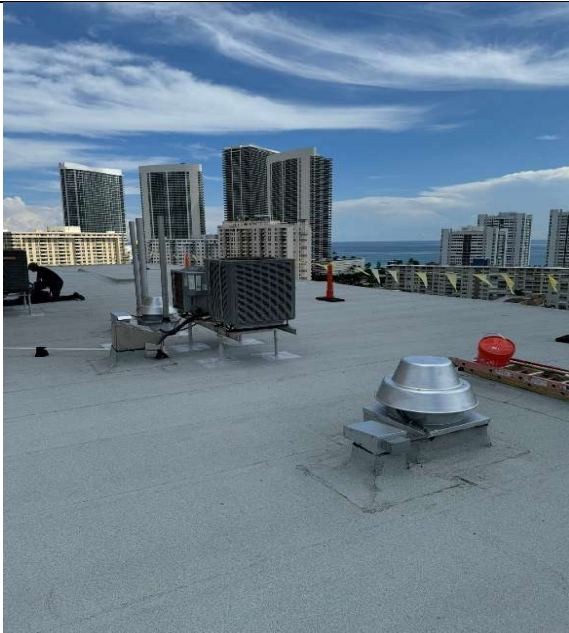
Roof is completely new. 2 ply modified roof system with tapered insulation.

Image 8: New roof completed.

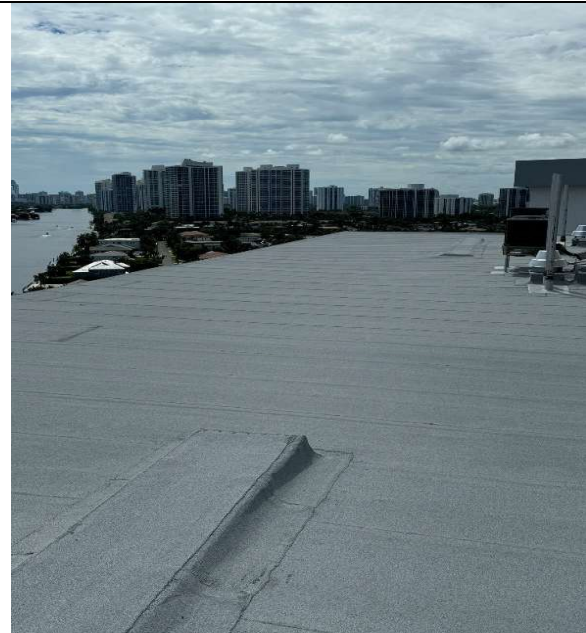
Image 9: New roof completed.
